Safespill IBC Tote Flare-up Test Report

April 2018

1. Introduction

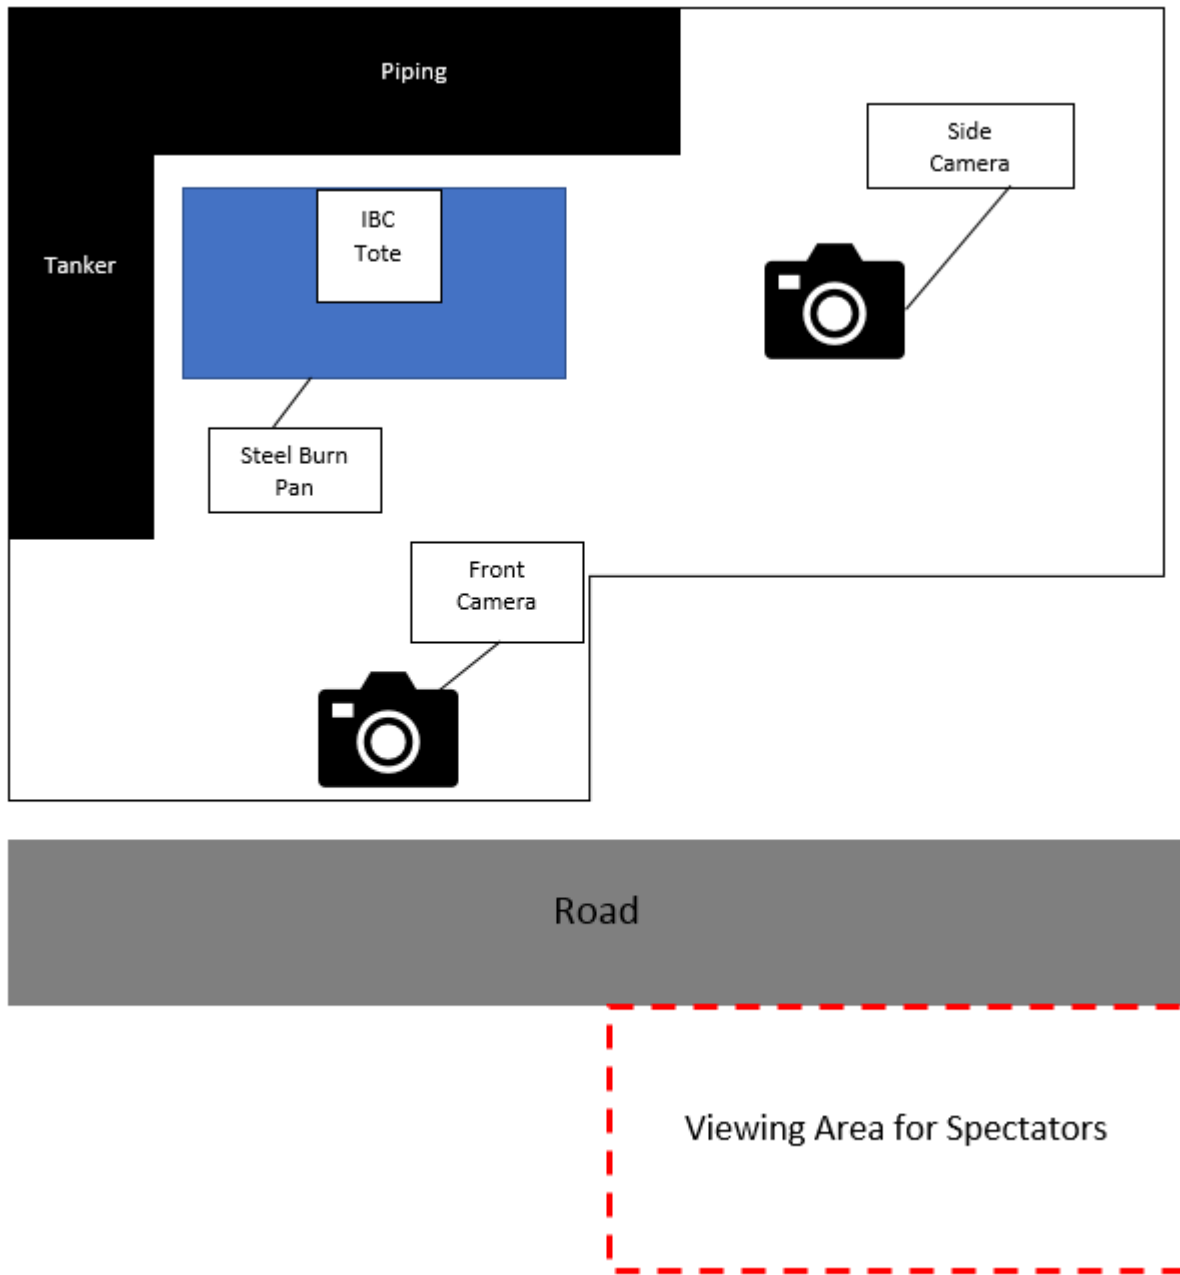
Figure 2.1: Bird's Eye View of Test Layout

1. Place steel burn pan so that spill guard on pan is facing the viewing area for the test and a clear line of sight exists for camera placement.
2. Fill IBC tote with prescribed volume of liquid, ensuring that valve is closed, cap is on valve, and cap on top of IBC is fully sealed.
3. Place IBC tote on steel pan, centered left to right and pushed to back of pan, away from spill guard as shown in Figure 2.1.
4. Allow tote to sit on pan and ignitable liquid to vaporize.
5. Firefighter will ignite rolled cotton igniter using propane torch.
6. Once breach has occurred, firefighter will use charged fire hose to extinguish fire terminating test.
7. Contents of steel pan will be drained into IBC tote, and liquid will be discharged to contaminated water storage and processing.

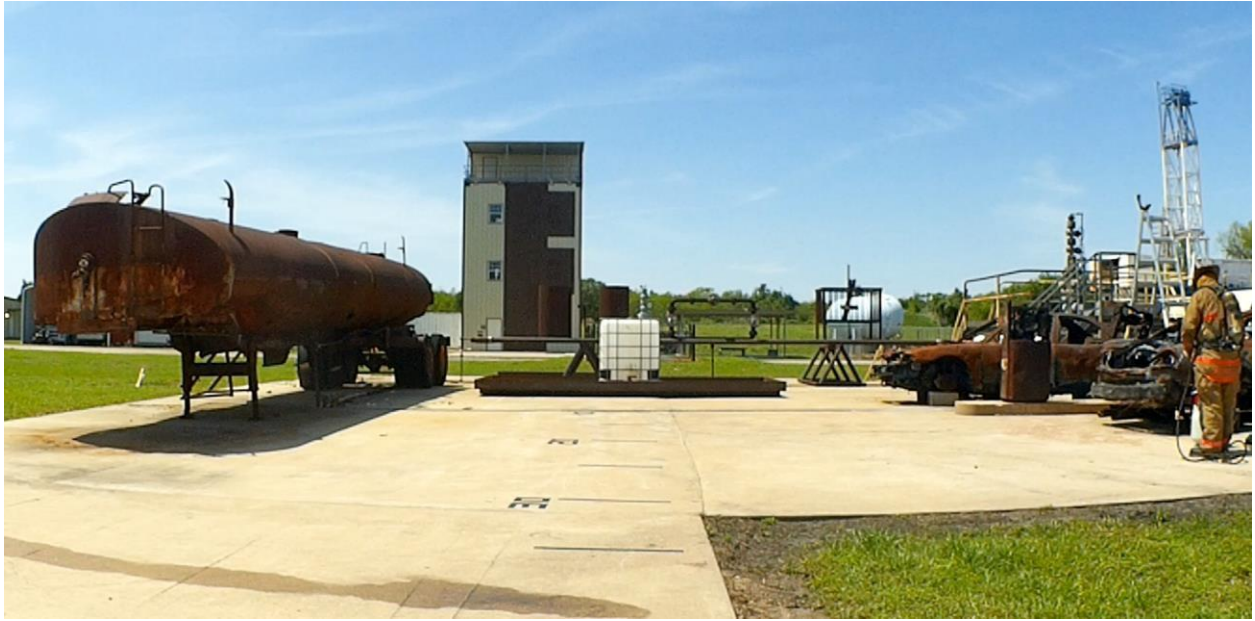
Figure 2.2: Testing Area from Front Camera

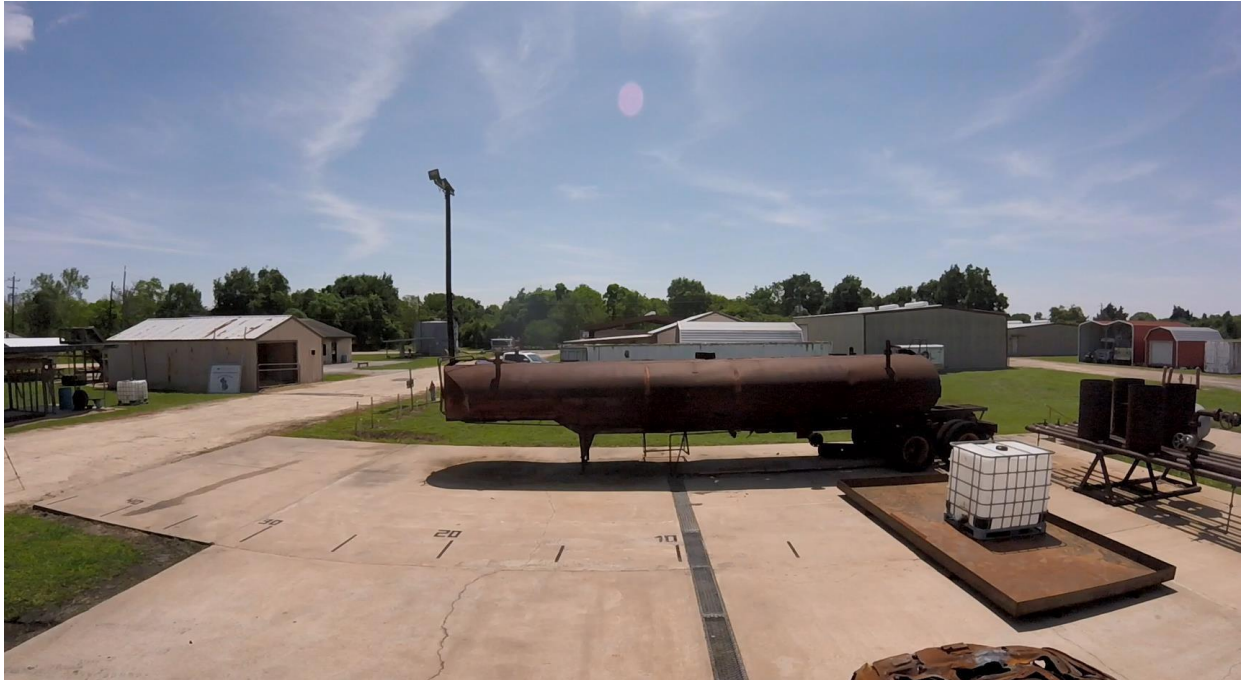
Figure 2.3: Testing Area from Side Camera

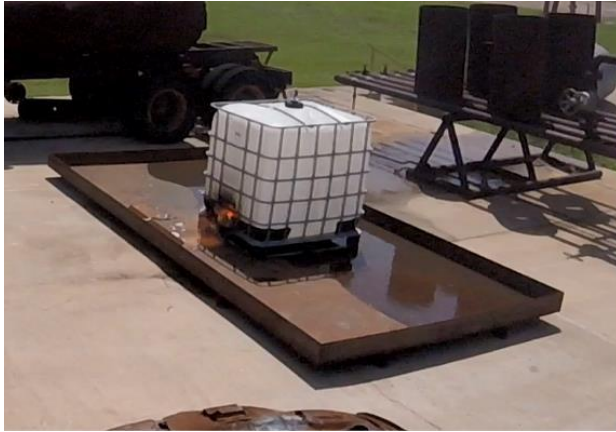
Figure 3.3: IBC inflation and initial vapor release

The test began with the ignition of a rolled cotton igniter. At 1 minute and 38 seconds, a major flare-up occurred. The flare-up began with a visible pressure buildup inside of the IBC (Figure 3.3), followed by a release of ignitable vapor (Figure 3.4). This vapor cloud was ignited, leading to a massive fire that engulfed the entire containment pan (Figure 3.5). The design of the pan appears to redirect the expanding gases laterally and the IBC is pushed backward. After the initial flare-up, isolated pool fires remained in the pan, and a plastic fire began to consume the IBC (Figure 3.6). A firefighter intervened at 2 minutes and 20 seconds, extinguishing the fire and terminating the test.

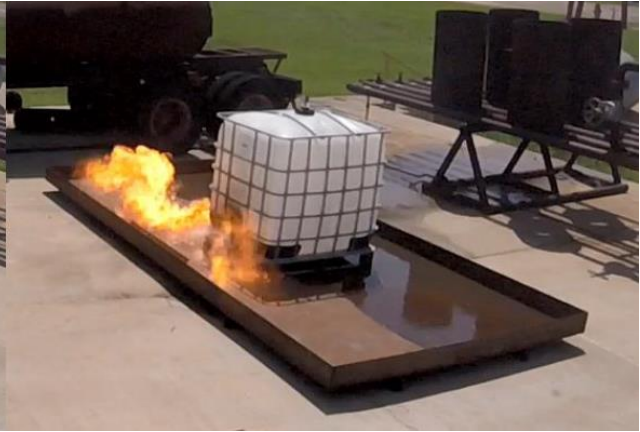
Figure 3.4: Initial vapor ignition

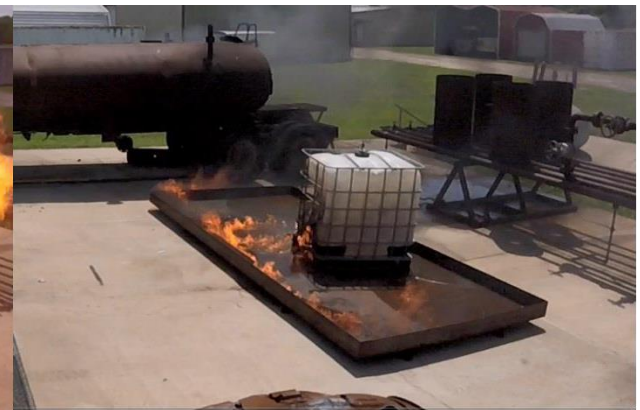
Figure 3.6: Pool fires and burning IBC following flare-up

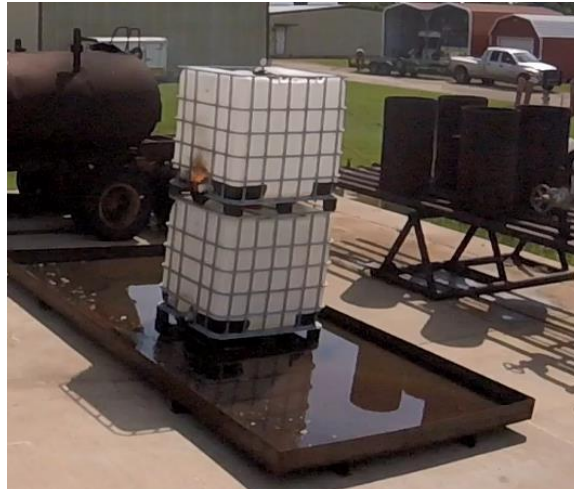
Figure 3.7: Second Tier IBC Set-up

Following the results of the first kerosene test, a second test was conducted with the filled IBC and rolled cotton igniter moved to a second tier IBC (Figure 3.7). The first tier IBC was clean, dry, and free of ignitable liquids. The second tier IBC was clean, dry, and filled with 10 gallons of kerosene. After filling the second tier IBC, the totes were positioned on the steel containment pan and left in direct sunlight for approximately 30 minutes before the test was initiated.

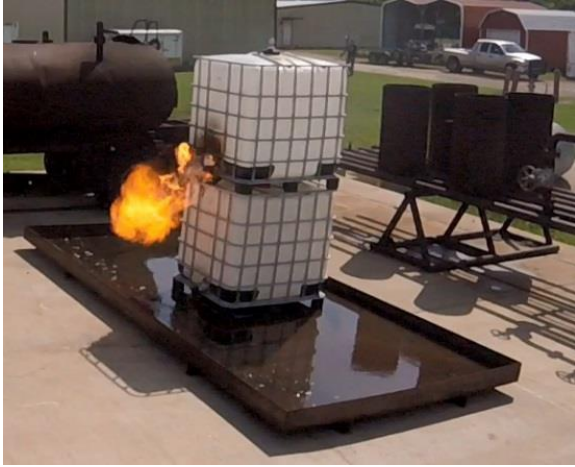
Figure 3.8: Tote inflation and initial vapor release

The test began with the ignition of a rolled cotton igniter. At 2 minute and 41 seconds, a major flare-up occurred. A simultaneous inflation of the second tier IBC and rapid release of partially ignited vapors occurred (Figure 3.8). The vapor cloud was ignited, and the resulting ball of fire extended nearly 30 feet beyond the edge of the containment pan (Figures 3.9 and 3.10). After the flare-up, a pool fire formed on one side of the stacked IBCs and both IBCs began to burn (Figure 3.11). Within 20 seconds of the initial flare-up, both IBCs and the entire containment pan were engulfed in flames (Figure 3.12). A firefighter intervened at 3 minutes and 54 seconds and was eventually able to extinguish the fire.

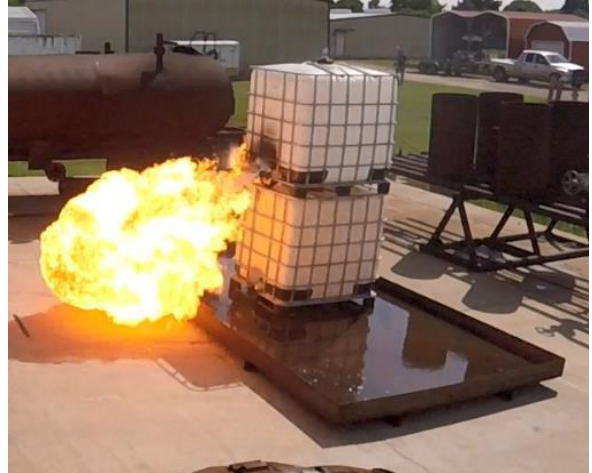
Figure 3.9: Vapor ignition

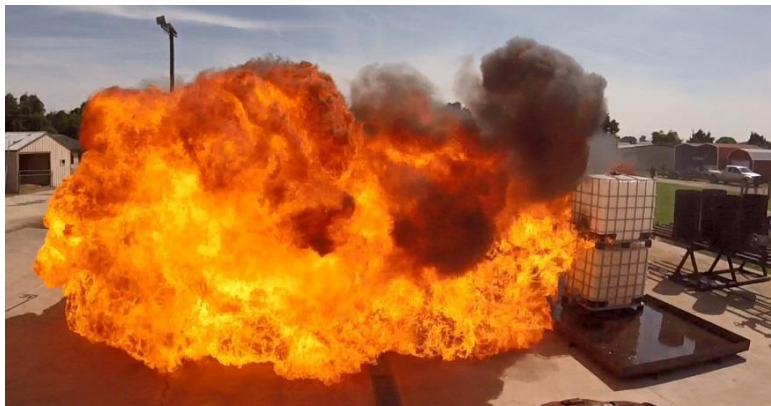
Figure 3.10: Ignited vapors create fire ball extending nearly 40 feet

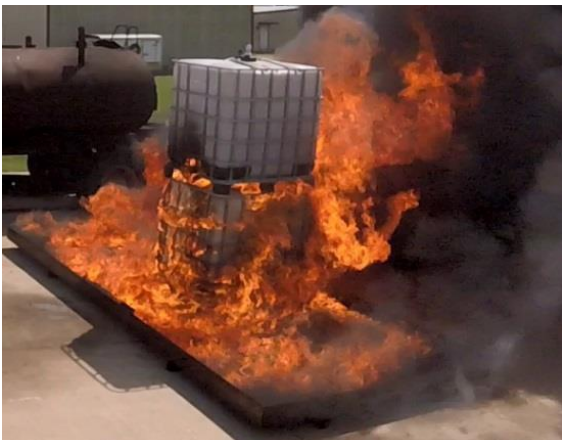
Figure 3.11: Pool fire fully consumes IBC totes

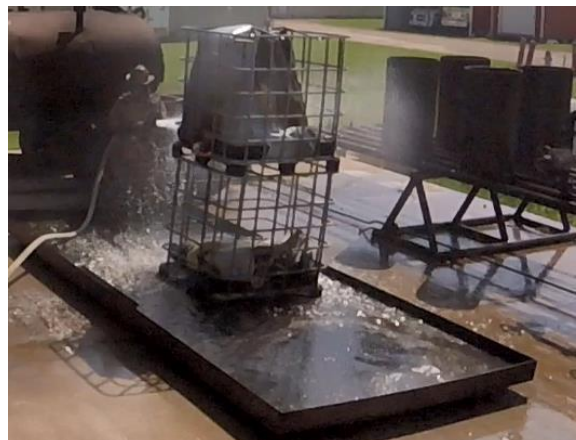
Figure 3.12: After extensive fire-fighting, IBCs are extinguished
